**Field Notes for my file: Oxford Center School, Oxford, CT  
Walkthrough of the 7 Campus buildings, Nov 5, 2015**

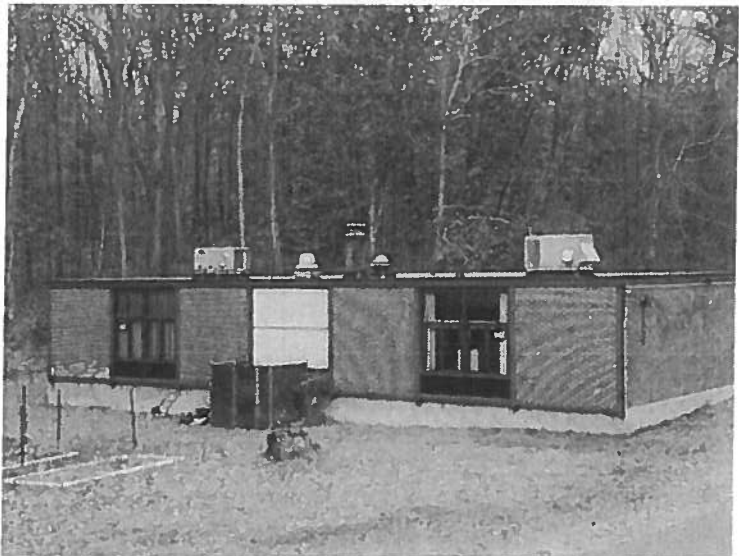
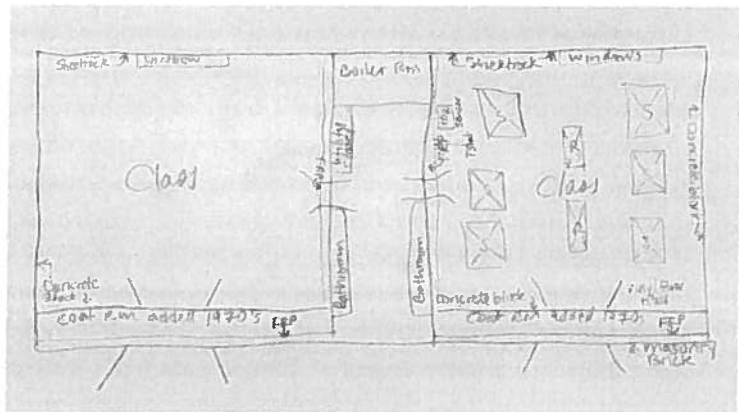
There are 7 identical campus buildings, or out buildings. Each is a rectangular masonry and concrete block building on concrete slab. Each building is comprised of 2 classrooms separated by a vestibule containing bathrooms, mechanical room, and utility closet. Another vestibule extending the entire length of the building along one side was added in the 1970's. This vestibule is called the 'coat room area' and is also used for storage. Inside of each building there are 2 concrete block walls, 1 wallboard wall, and 1 fiberglass reinforced panel (FRG) wall (new). Each building has 2 rooftop packaged HVAC units (RTUs), one for each classroom. These were added sometime after 2003. The buildings each have their own above ground oil tanks surrounded by metal fencing. After our visit, I learned from John Barlow that the campus buildings each have an underground septic tank- these were abandoned years ago. John spoke to a retired teacher recently. She told him that septic – like odors were a persistent and routine problem in her campus building when she taught at this school. She recently visited the school and remarked that the current odor was nothing like what she remembered from her teaching days at this school.
